# Irwin Shire Council

## Municipal Inventory Place Record

**Place Details**      **Place Number:** 115      **Category:** 1A      **HCWA No:** 1215  
**TPS No:** 62      **Assessment Date:** 05/08/1997      **Last Revision Date:** 24/09/2004

**Name:** The Grange  
**Former Name:**  
**Type of Place:** House and Outbuildings  
**Address:** Wye Farm Road  
**Map Reference:** HUNT 1:2000 BE42/35.03  
**Locality Name:** Yardarino      **Area of Site:**  
**GPS Northing:**      **GPS Easting:**

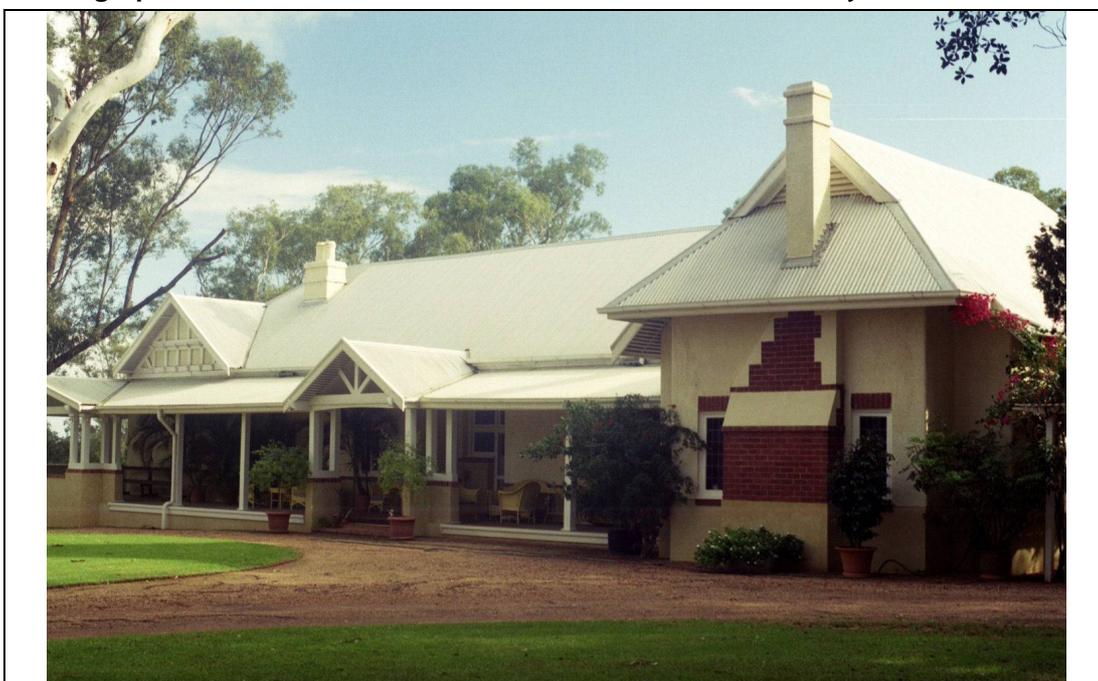
The Grange, front elevation

The main house is large and is constructed of brick with a tuckpointed brick and render finish. The complex corrugated iron main roof has a high pitch and consists of a central hipped roof with a small gable to the south-east and a large dutch gable to the north-east. The dutch gable roof is punctuated by a tall corbelled chimney. A separate verandah, which is supported on double timber posts set on tall masonry piers, runs between the gables on the east façade and continues around the south façade. The centre of the east verandah is enhanced by a gable. Windows are timber framed and casement style. The place is set in magnificent grounds with mature trees of several species located around the house.

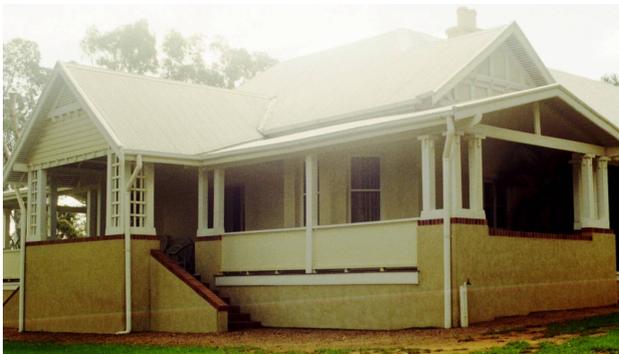
**Date of Photograph:** 5/06/2004 IR115-1

The Grange, southeast corner

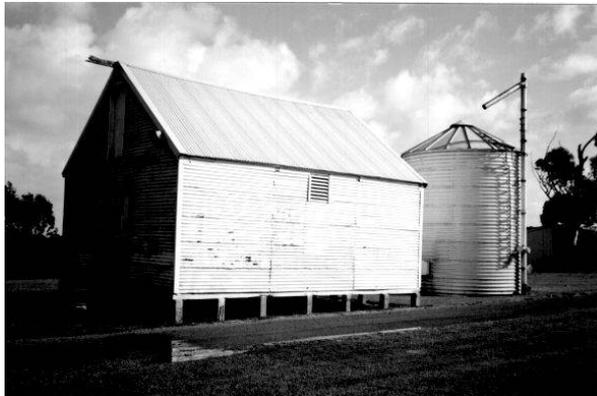
**Date of Photograph:** 5/08/1997 IR115-10

This rectangular corrugated iron building is located to the west of the main house. It is set on concrete stumps and has timber vents set high on the north and south walls. The east wall has a loft entry door set into the gable end below which is a sliding timber door. Access to the sliding door is via timber steps to a raised deck.

The Granary, northwest aspect.

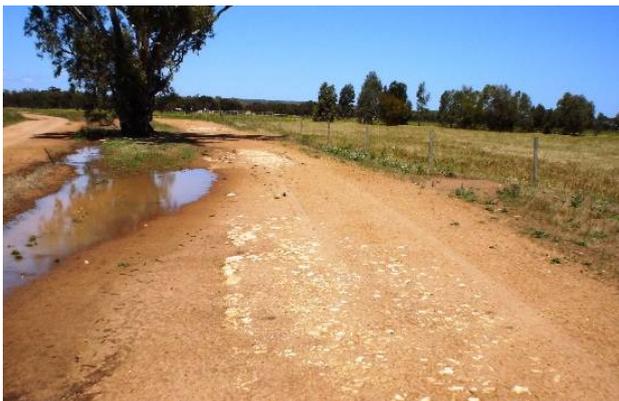
**Date of Photograph:** 24/09/2004 IR115-11

A section of road about 500m north of the homestead is of limestone construction. The Shire of Irwin has made a diversion alongside the limestone section to remove traffic and the need for grading along it. It is believed this is an early example of road construction techniques used in the district, possibly ticket-of-leave workers were employed in its construction.

Section of old limestone road, the diversion road seen on the left.

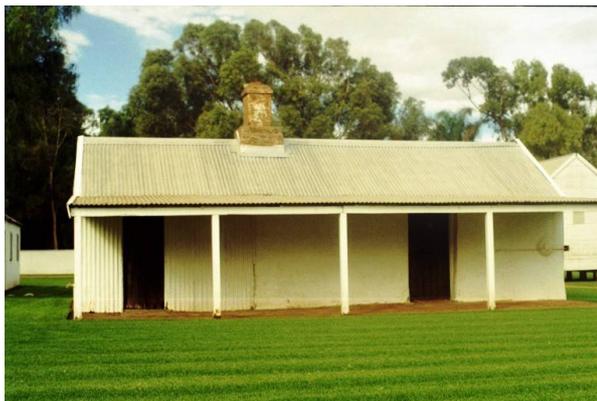
**Date of Photograph:** 5/06/2004 IR115-2

Located to the west of the main house, this simple rectangular structure is constructed of lime washed random rubble stone with a timber frame and corrugated iron extension to the north. The corrugated iron gable roof has a brick chimney set above the gable and has a broken back extension that covers the verandah to the west. The verandah is supported on timber posts. Small timber windows are set into the east wall, and two entry doors are set into the west wall. Two small open vents are located in the south wall below the gable end.

Shepherd's cottage, west side

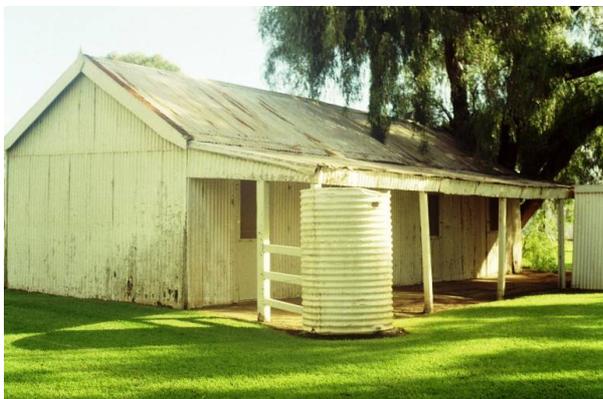
**Date of Photograph:** 5/06/2004 IR115-3

This simple white washed timber frame and corrugated iron structure runs west to east and is located to the north-west of the main house. The main roof has broken back extension which forms a verandah to the north and is supported on timber posts. The quarters are accessed through five doors set into the north wall. A small timber frame and corrugated iron ablution block is located immediately to the north-west of the building.

Shearer's Quarters, southeast aspect.

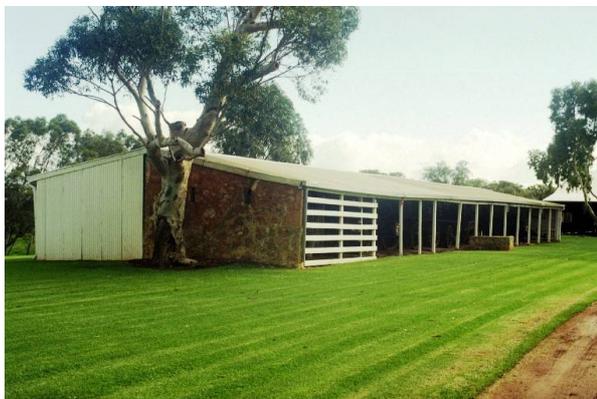
**Date of Photograph:** 5/06/2004 IR115-4

This long building is located to the west of the granary and has a low-pitched corrugated iron gable roof. Its walls are a combination of random rubble stone and corrugated iron. The north and central south section of the structure are open and supported on timber posts. Internally, there are rooms which accommodate a dairy, tack room and blacksmith's shop. Immediately to the west of this shed are the ruins of a slaughterhouse.

Stone and Post shed, northeast aspect.

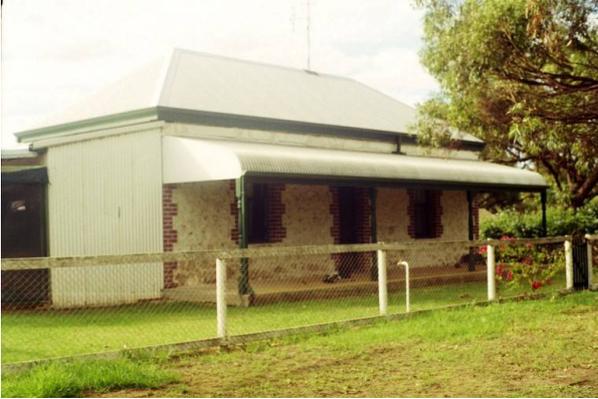
**Date of Photograph:** 5/06/2004 IR115-5

This small cottage faces south and is of limestone and corrugated iron construction and is located to the west of the outbuildings. The cottage has four rooms, central passage and front and back verandah. The front walls, doorway and windows have brick quoining and the front bullnosed front verandah is supported on four green painted turned timber posts. The cottage is in good condition, some shade cloth covered areas are adjacent to the north and east sides.

The Grange workmen's cottage

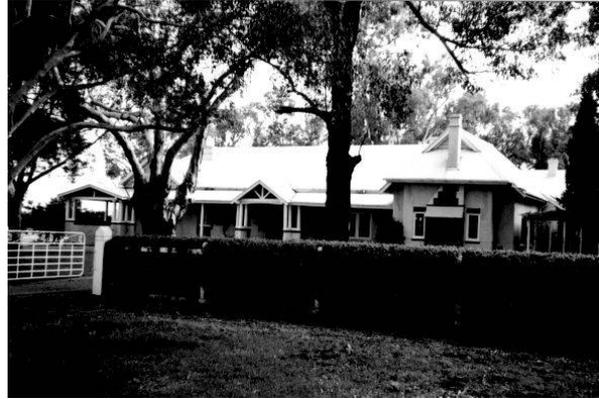
**Date of Photograph:** 5/08/1997 IR115-6

The Grange east side, showing entry gate and plumbago hedge.

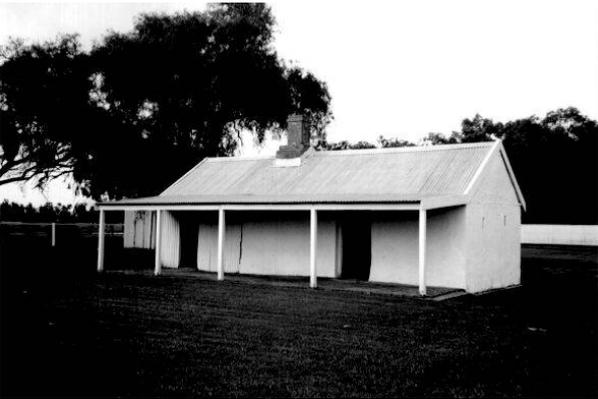
**Date of Photograph:** 5/08/1997 IR115-7

Shepherd's Cottage, southwest aspect

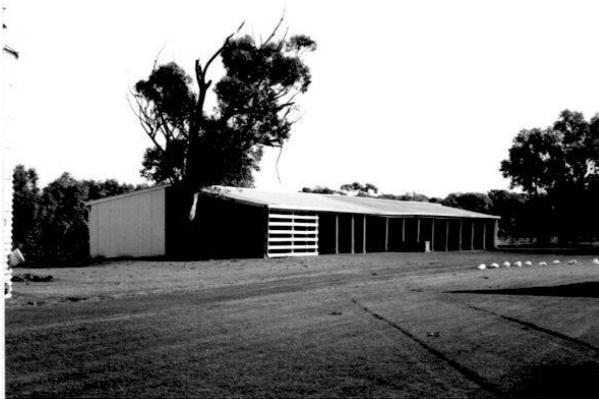
**Date of Photograph:** 5/08/1997 IR115-8

Stone and post shed, northeast aspect

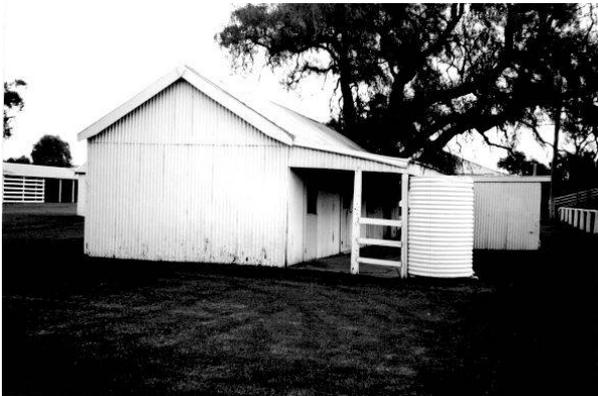
**Date of Photograph:** 5/08/1997 IR115-9

Shearer's Quarters, northwest aspect.
