Irwin Shire Council

Municipal Inventory Place Record

Name: Tyford
Former Name:
Type of Place: House
Address: Brand Highway
Map Reference: HUNT 1:2000 BE42/35.03
Locality Name: Dongara **Area of Site:**
GPS Northing: **GPS Easting:**

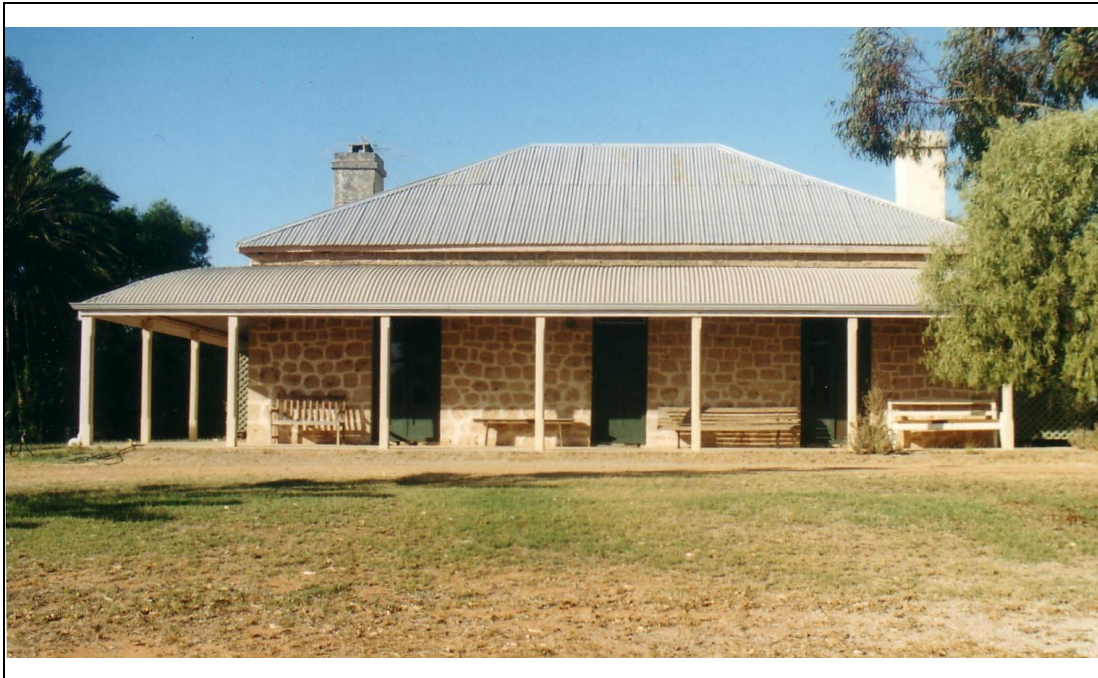
Stone house to the south

Constructed of limestone this house has a hipped corrugated iron roof with separate verandahs. There are two large stone chimneys. The verandahs have an usual style roof of curved corrugated iron which is supported on moulded concrete (replacement) chamfered posts. Verandah floors are concrete. The east side of the verandah has stone infill. The front (south) elevation has two french doors with a central entry door with fanlight above situated between them. Windows are timber framed, casement style.

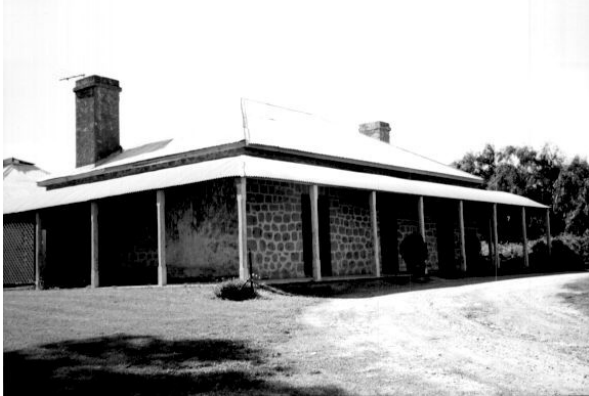
Date of Photograph: 15/10/1996 IR098-1

Tyford Stone farmhouse

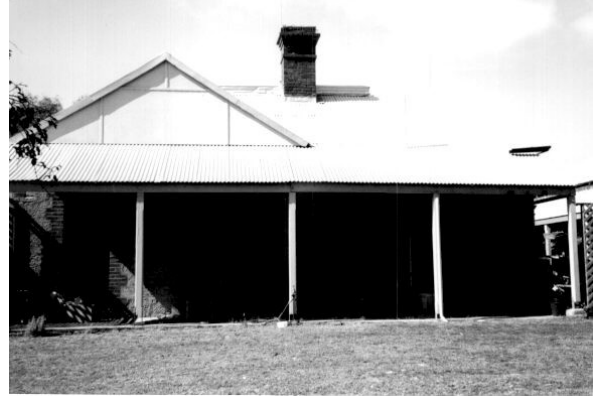
Date of Photograph: 16/10/1996 IR098-2

The east (rear) original section of the house is constructed of limestone with a pitched corrugated iron roof. The newer section to the west is limestone with brick quoining to openings and corners. The steeply pitched corrugated iron roof is punctuated by a brick chimney above. A gable end to the west of the main roof extends to cover the front verandah which is supported on chamfered timber posts. Windows are timber framed and double hung. The front house (south) parallels this structure and forms a breezeway about 5m wide between the two structures.

Brick farmhouse

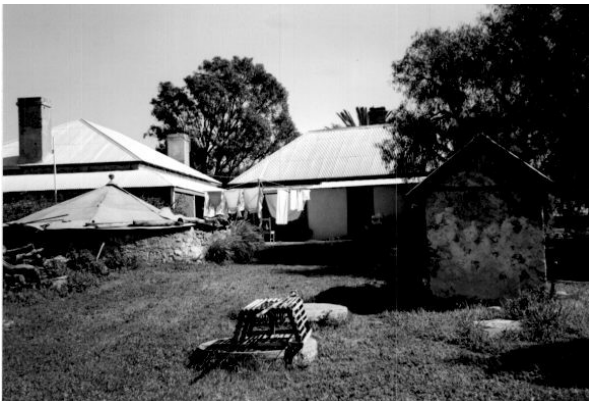
Date of Photograph: 16/10/1996 IR098-3

A large stone circular underground tank is situated about five metres to the east of the breezeway. It has a pitched roof of flat sheets of corrugated iron with a decorative metal vent to the centre. The stone privy is situated about twenty metres to the north-east of the rear house and has a gable corrugated iron roof.

Underground tank & privy
